Manhole Inspection Summary

Manhole # S19GG_017MH

Insp Date: **6/13/07 12:39 PM**

Location Address: **2000 PRESSTMAN ST**

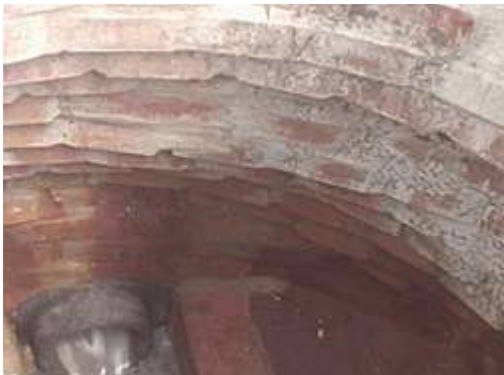
Defect 3

Infiltration: ☐ None ☐ Joint ☐ Cracks ☐ Mortar ☐ Roots ☒ **Wall**

BARREL INFILTRATION

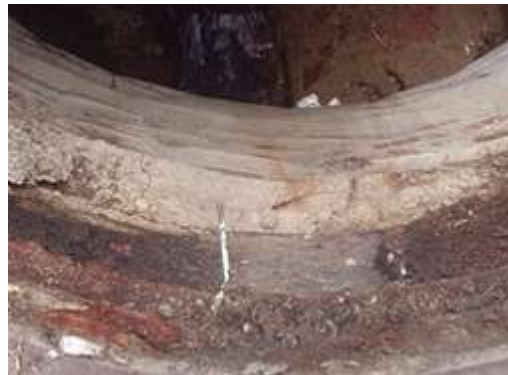
Defect 2

Offset: **2** (in.)

FRAME OFFSET

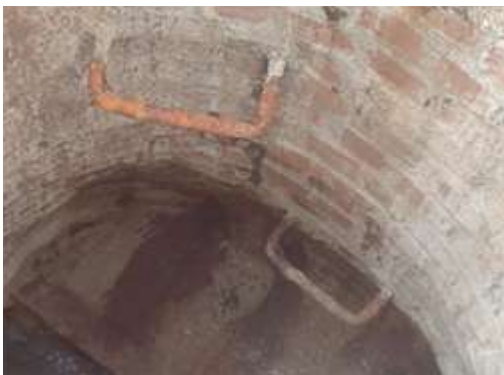
Defect 1

Count: **2** Missing: **0** ☒ **Corroded**

CORRODED STEPS

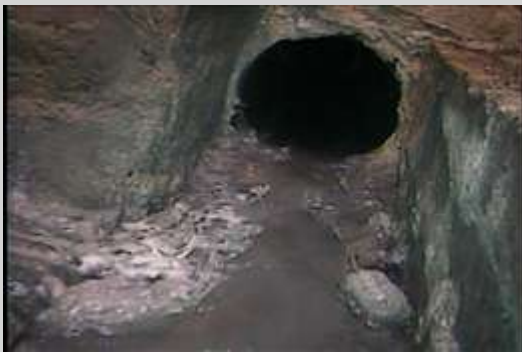
12 O'Clock Outflow

Pipe Height: **8.4** (in.) Rod and Bar (Angled)
Pipe Material: **Clay** ☐ Pipe Lined
Invert Depth: **7.06** (ft.) Flow Characteristics: **Slow**
Deposits: ☐ None ☐ Mud ☐ Sludge ☒ **Debris** ☐ Grease
Silt Depth: **3** (in.) Deposits Extent: **Light**
Infiltration: **None** Pipe Seal Cond: **Sound**

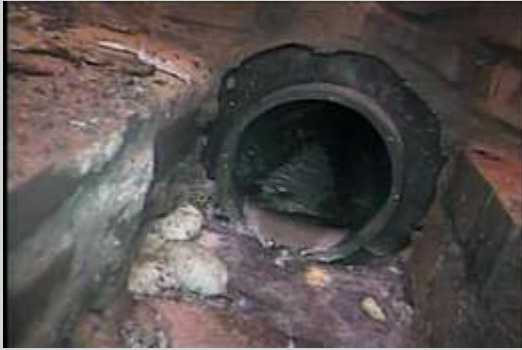
9 O'Clock Inflow

Deposits: ☐ None ☐ Mud ☐ Sludge ☒ **Debris** ☐ Grease

Silt Depth: **2** (in.) Deposits Extent: **Light**
